A REPORT SUBMITTED
BY
THE COMMITTEE OF ENQUIRY
ON
THE FIRE DISASTER
AT
OKAISHIE-MAKOLA
ON
MONDAY, 5TH JULY, 2021

THE STRUCTURAL INTEGRITY ASSESSMENT OF THE AFFECTED BUILDING

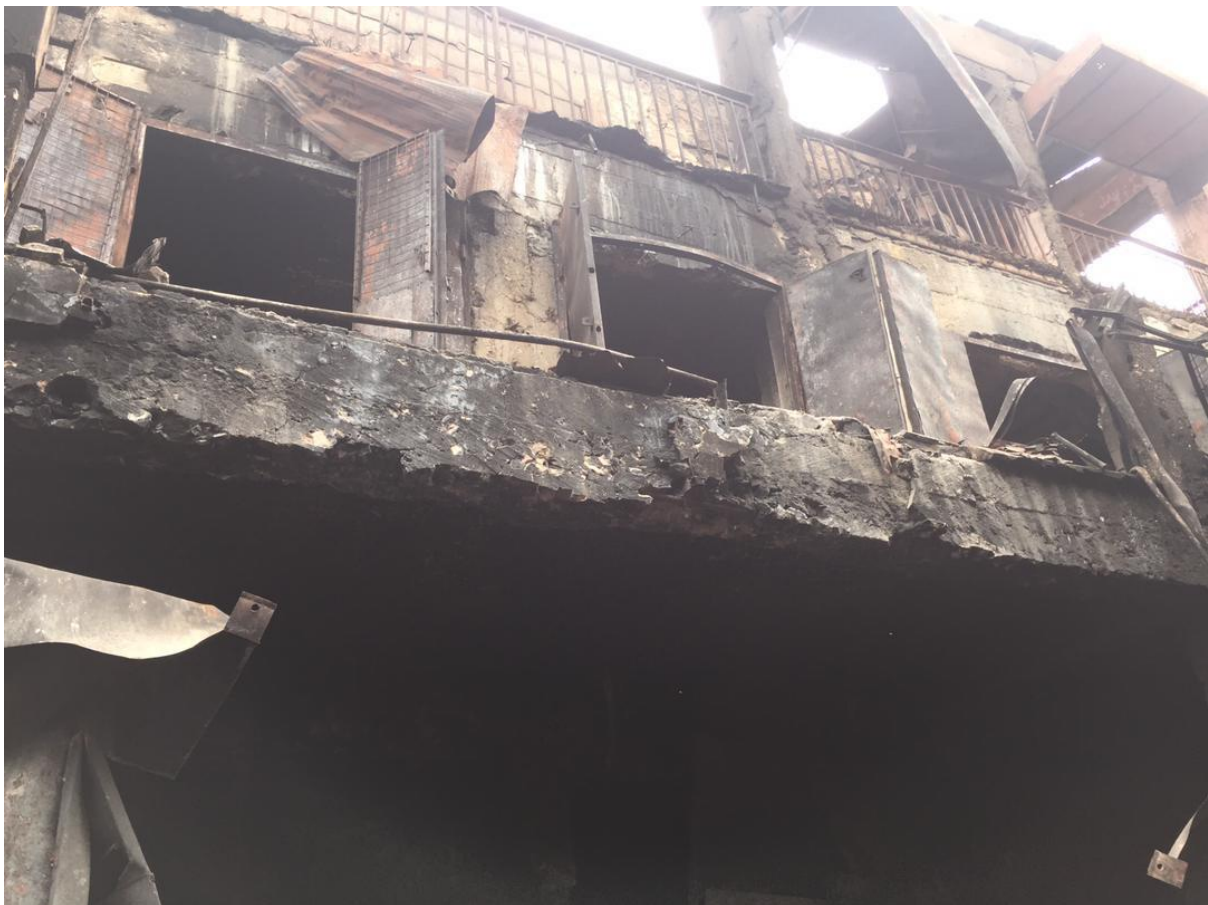
Figure 1.1 Overview of the Structure

Currently, the building was splited into two sections/wings, namely the eastern and western sections. Four floors occupy the eastern section of the building whiles three occupy the western. Most of the damages sustained by the structure during the fire outbreak, was sustained on the upper floors of the building with the ground floor having minimal damage. The most severe of the damage caused by the fire was relatively isolated to the south of the eastern wing. Here, significant damage had been caused to the structural members of the building with visible cracks present everywhere.

This visible and extensive cracks in the structural members of the building was an indicator that several members present within the structural framework were on the verge of collapse.

As seen in the preceding paragraphs it could be concluded that of the five levels present in the structure, only the members of the ground floor and the basement retained their functionality with the 1st, 2nd and 3rd floor members haven been compromised. It was therefore recommended that either the 1st, 2nd and 3rd floors of the building be removed completely and rebuilt or the entire structure be completely demolished and built anew.

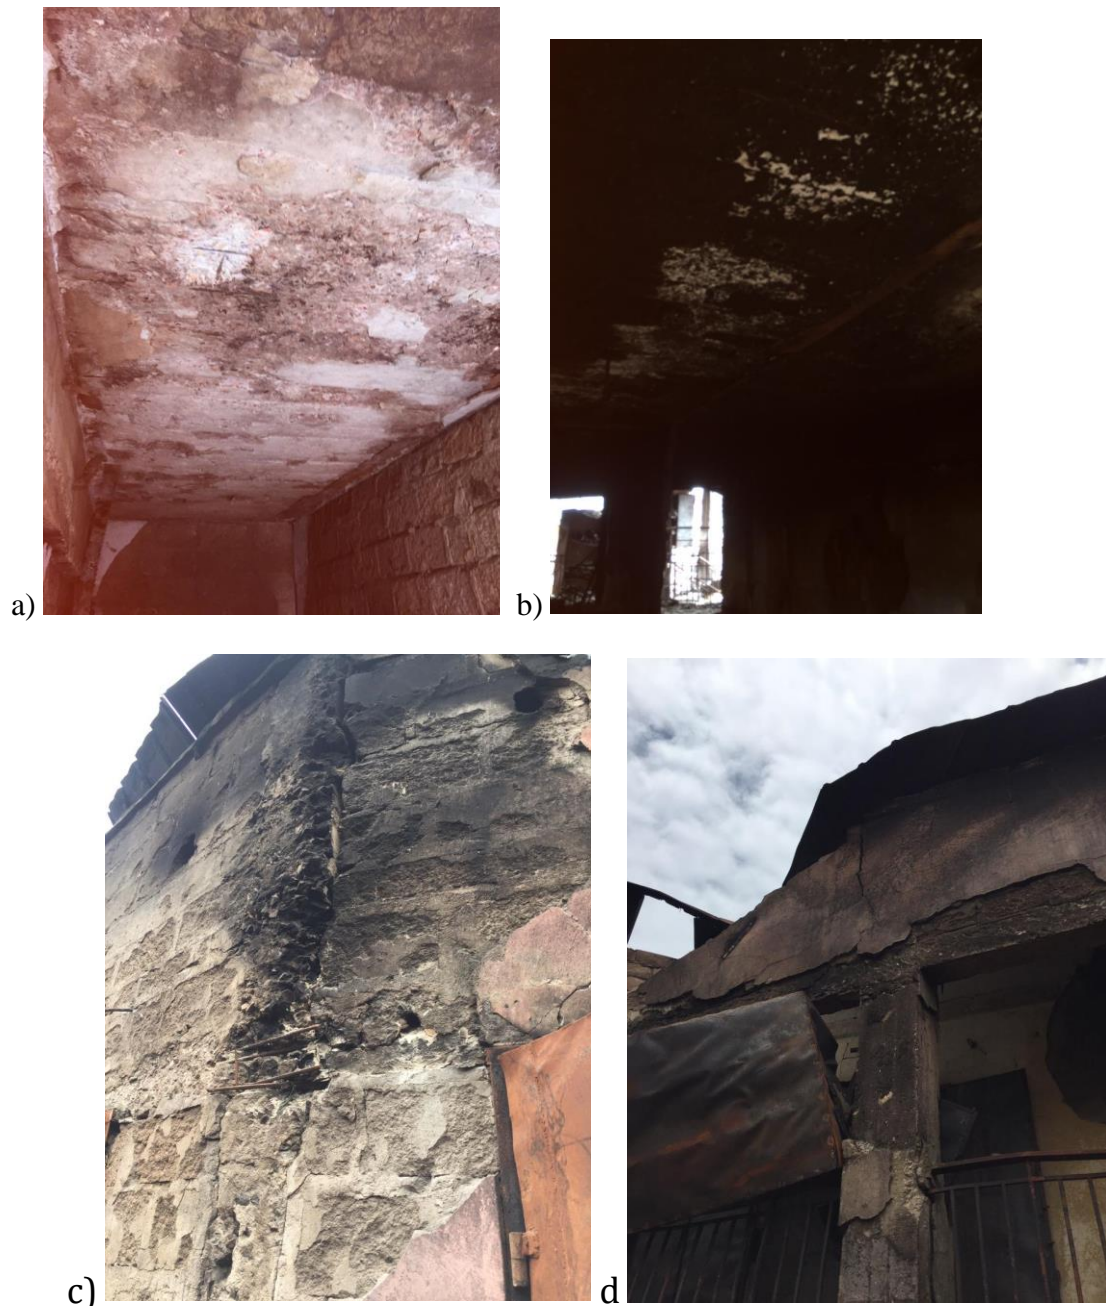
Figure 2.1 Pre-existing and Fire related Cracks

A visual representation of these weaknesses could be seen in the presence of pre-existing cracking prior to the fire. The development of new cracks from the fire outbreak further compromised the strength of the structural members. It was safe to then conclude that the structural integrity of the 2nd and 3rd floor were compromised and could not be refurbished for the structure's commercial purposes.

1. That as per the result of the structural integrity assessment test on the current nature of the burnt building, it should be pulled down for reconstruction since its current state was a risk to those who would like to occupy it and to the general public who may have to do business there.
2. The estimated cost of the initial assessment on the financial loss to

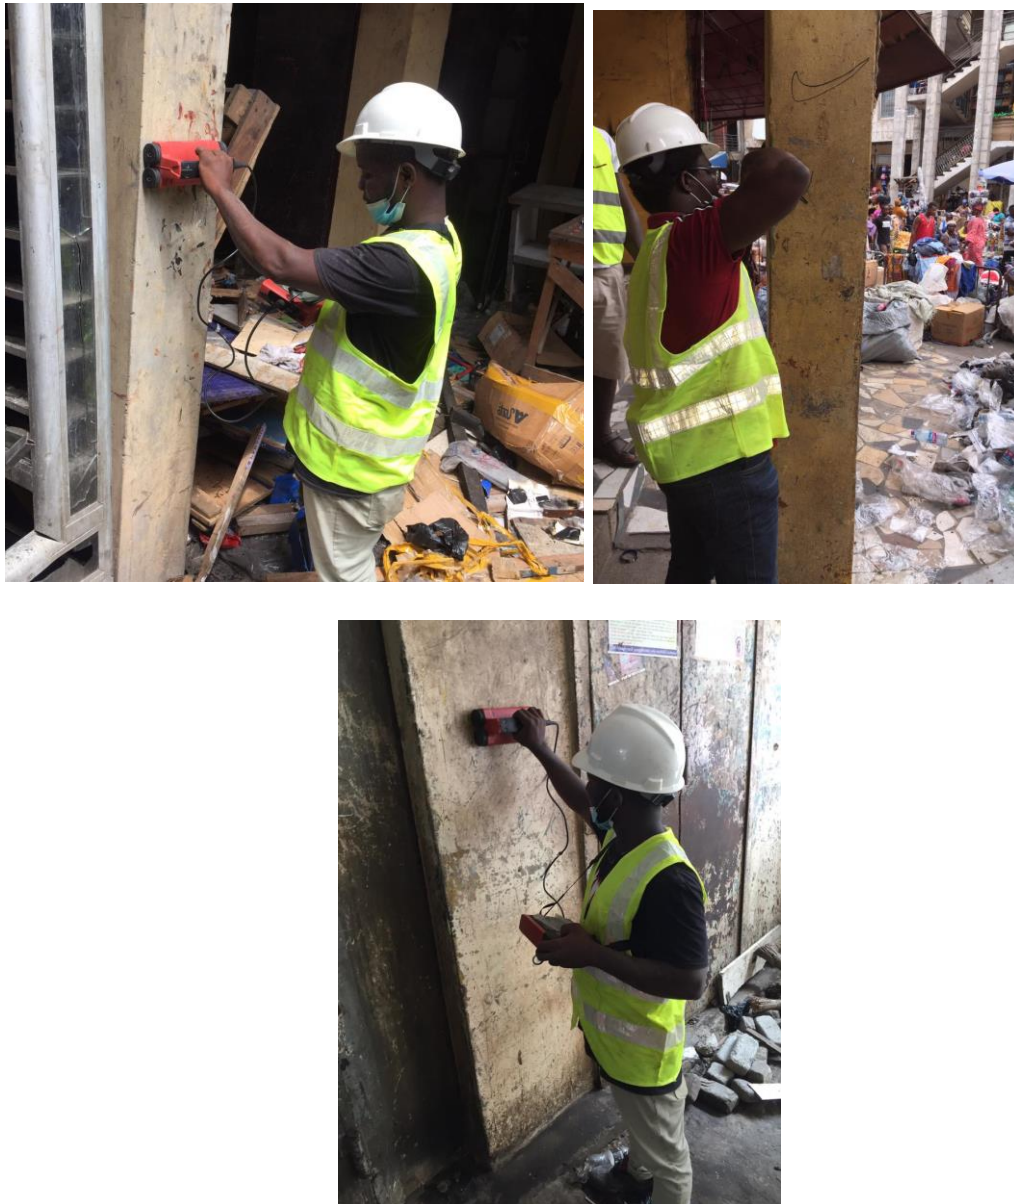
Figure 2.2 Determining the reinforcement used on members

From the tests conducted, it was observed that the various columns present within the existing structure contained 16mm bars with 10mm stirrups at 150mm c/c arrangements. A concrete cover of about 25mm had been provided as cover for the mild steel rods used in the reinforcement.

Minimum covers to reinforcements in the columns and foundation on site were less than the prescribed 20mm for the columns and the 40 mm for the foundations.

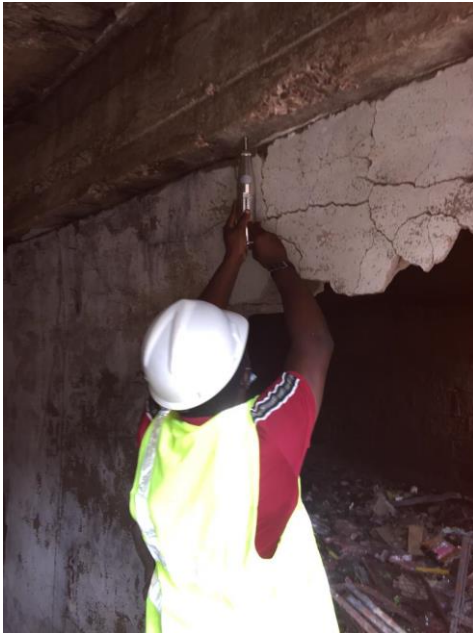
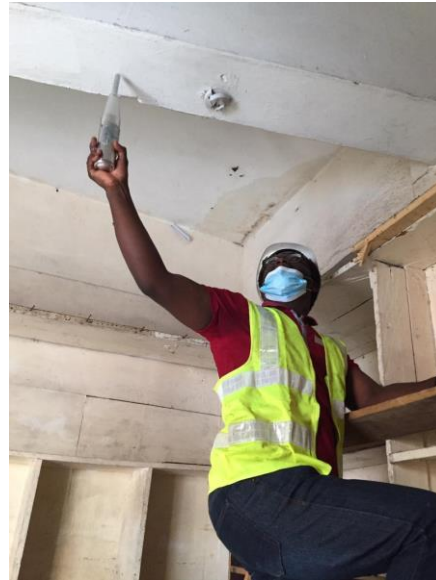
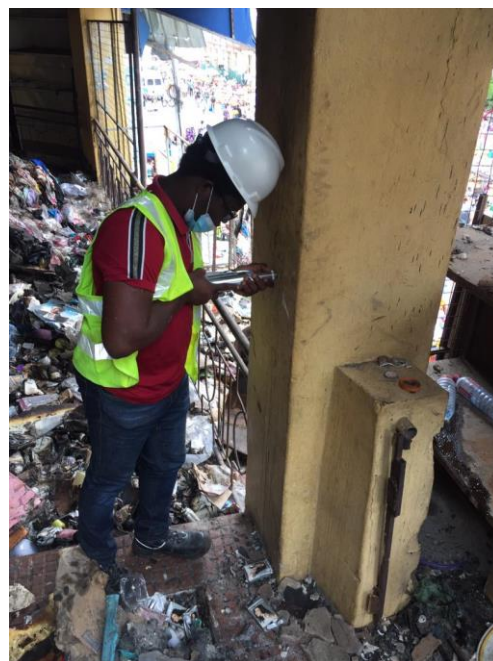
Figure 2.3 Determining the compressive strength of members

Based on the various aspects of the structural assessment conducted it was realized that the built structure although having had a good arrangement and size distribution of all structural members on all floors, the strength of the materials used on some aspects of the arrangement, 2nd and 3rd floors, the casting of these members were sub-par and fail a minimum compressive strength of 25KN/m² designated for a structure as this.

members of the floor could be seen in the south of the eastern wing of the floor. There were various cracks identified and the compressive strength tests of those members' revealed relatively low results as seen in table 2.1. The 1st floor like the 2nd and 3rd floors was also compromised and as such had come to the end of its service life.

With compressive strengths greater than or slightly below the recommended 25KN/mm² and emerging relatively unscathed in the fire outbreak the structural members of the ground floor and the basement were structurally sound and only needed some renovation works to have it functioning again.

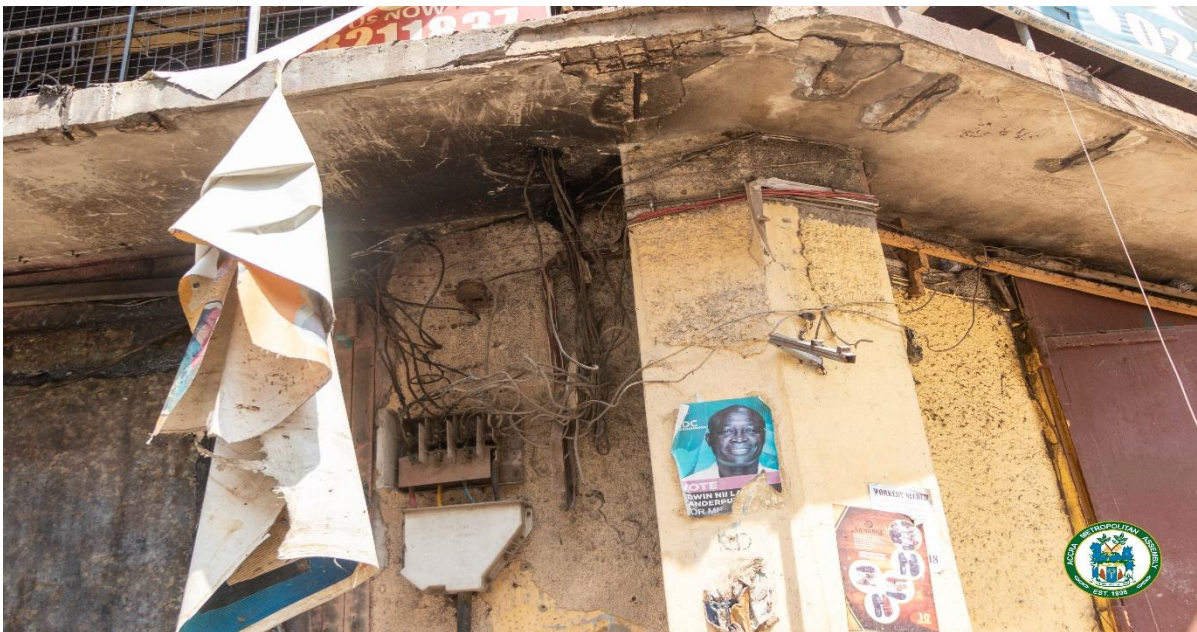
PICTURE 8:

After the disaster, the committee walked through the building, and it was visibly observed that most electrical wires were not properly installed in the building and therefore haphazardly exposed. By those unorganised arrangements, it was obvious that any spark of fire could not be easily controlled. The described

scenario of electrical wiring in the affected building could be said to be exact situation in the adjoining buildings in the Makola-Okaishie enclave

Exposed wiring on the building that caught fire captured on Tuesday 13th July, 2021

when members of the committee of enquiry visited the disaster scene.

7. To ensure that electrical faults and related repair works in the buildings of the market conform to standards, the committee recommended that the Electricity Company of Ghana should assign a certified professional electrician to each building as a supervisor or a care taker of all electrical works in that building. This move would reduce the multiple hands of unstandardized electrical works that resulted in intermittent electrical sparks.

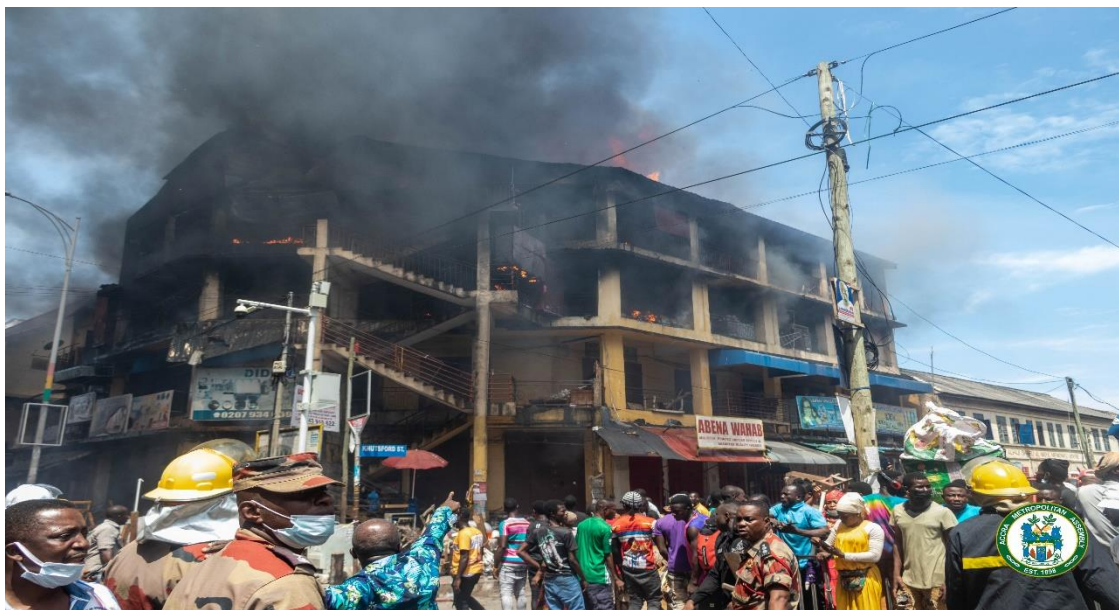
PICTURE 10:

The affected building has a basement with few shops, a ground floor, first, second and third floors. While the second and third floors were utterly destroyed, the first floor slightly, the ground and the basement did not experience any burning but suffered from watering as a result of the firefighting process.

A front view shot of the three (3) storey building at Okaishie - Makola Market that got gutted by fire. Date: 5th July, 2021.
