A REPORT SUBMITTED
BY
THE COMMITTEE OF ENQUIRY
ON
THE FIRE DISASTER
AT
OKAISHIE-MAKOLA
ON
MONDAY, 5TH JULY, 2021

THE STRUCTURAL INTEGRITY ASSESSMENT OF THE AFFECTED BUILDING

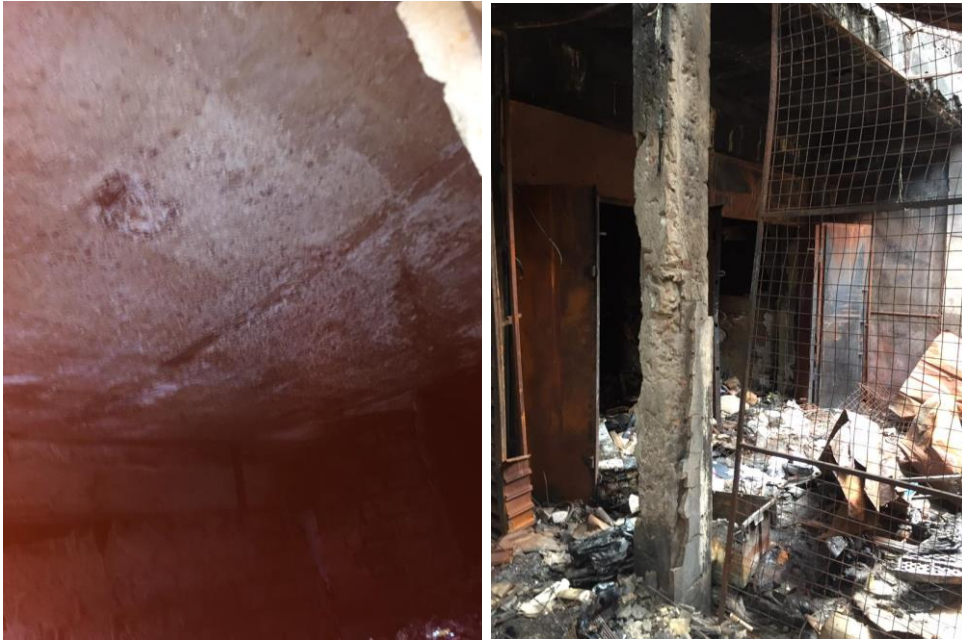
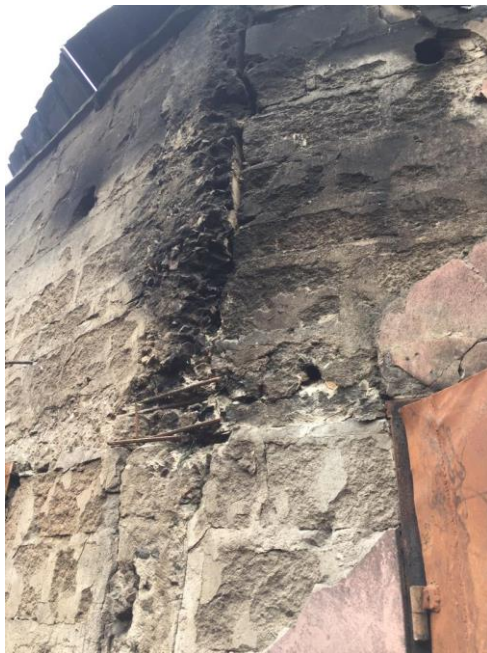
Figure 2.1 Pre-existing and Fire related Cracks

Currently, the building was splited into two sections/wings, namely the eastern and western sections. Four floors occupy the eastern section of the building whiles three occupy the western. Most of the damages sustained by the structure during the fire outbreak, was sustained on the upper floors of the building with the ground floor having minimal damage. The most severe of the damage caused by the fire was relatively isolated to the south of the eastern wing. Here, significant damage had been caused to the structural members of the building with visible cracks present everywhere.

This visible and extensive cracks in the structural members of the building was an indicator that several members present within the structural framework were on the verge of collapse.

A visual representation of these weaknesses could be seen in the presence of pre-existing cracking prior to the fire. The development of new cracks from the fire outbreak further compromised the strength of the structural members. It was safe to then conclude that the structural integrity of the 2nd and 3rd floor were compromised and could not be refurbished for the structure's commercial purposes.

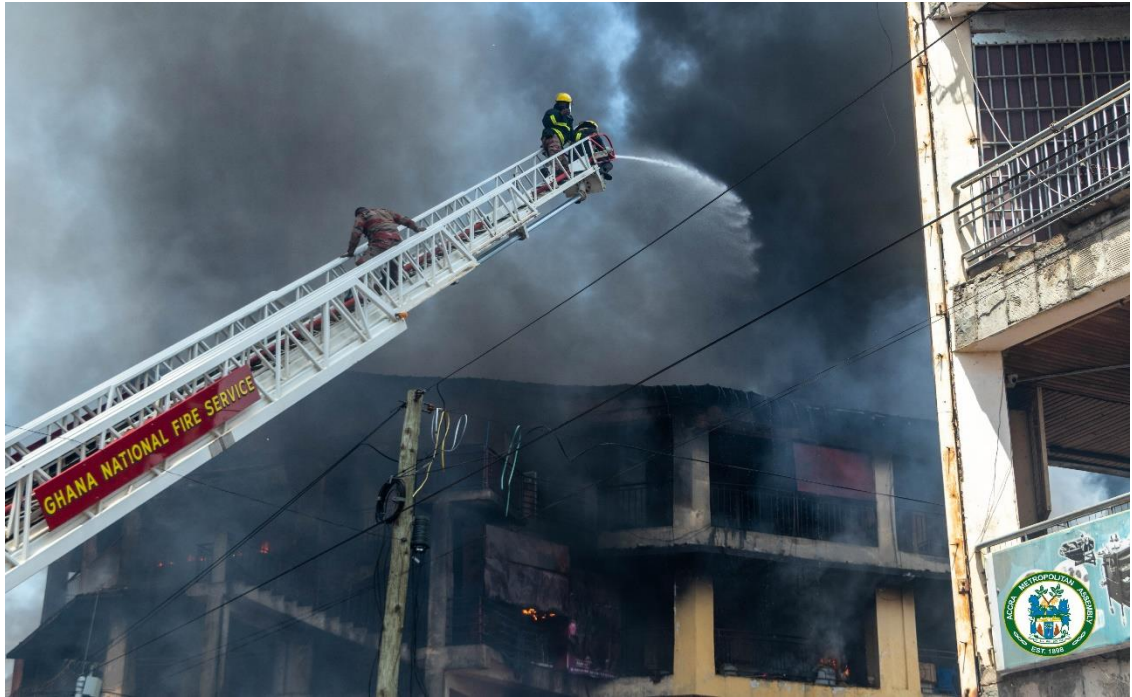
PICTURE 1:

Officers of the Ghana National Fire Service (GNFS) extinguishing the fire with an aerial platform on Monday 5th July, 2021

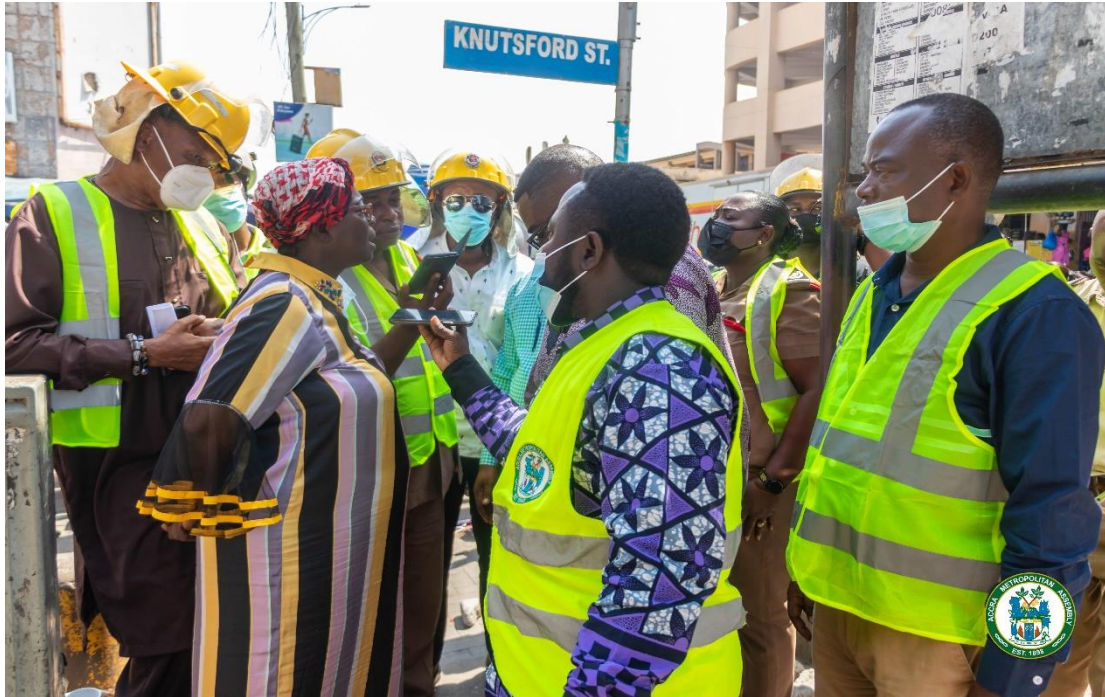
PICTURE 5:

The Committee of Enquiry at the scene of the disaster to assess the level of damage and also interview some victims on Tuesday, 13th July, 2021

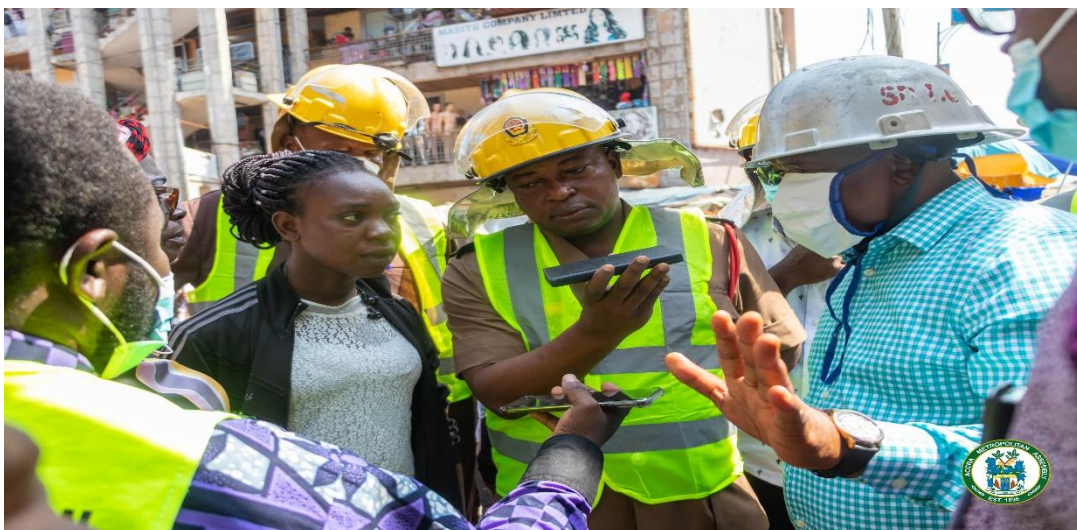
PICTURE 6:

The Committee of Enquiry at the scene of the disaster to assess the level of damage and also interview some victims on Tuesday, 13th July, 2021

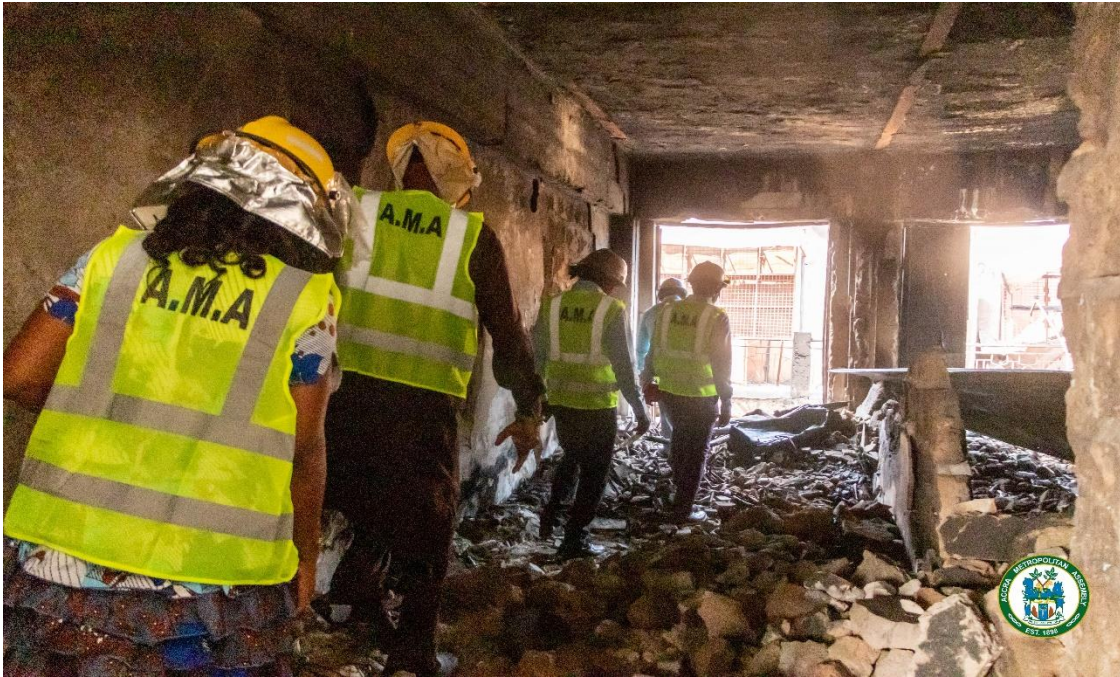
PICTURE 7:

Members of the Committee of Enquiry at the scene of the disaster to assess the level of damage on Tuesday, 13th July, 2021
